Project Title: Hoaloha Park Adaptation Plan

Technical Memorandum No. 1

Subject: Site Existing Conditions

Date: August 30, 2024

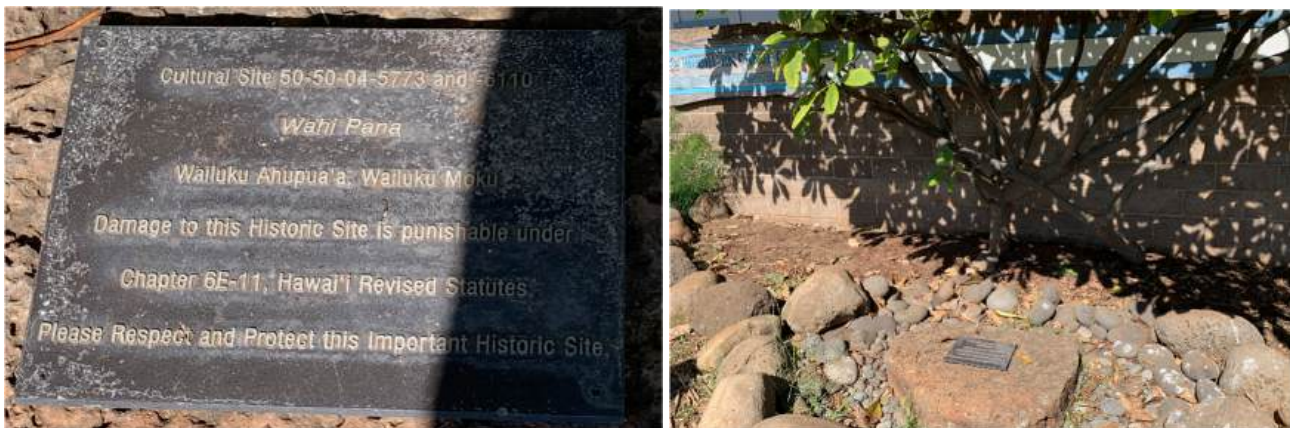
Figure 4.7 Cultural Site 50-50-04-5773 located behind HCC Canoe Hale (Brown and Caldwell)

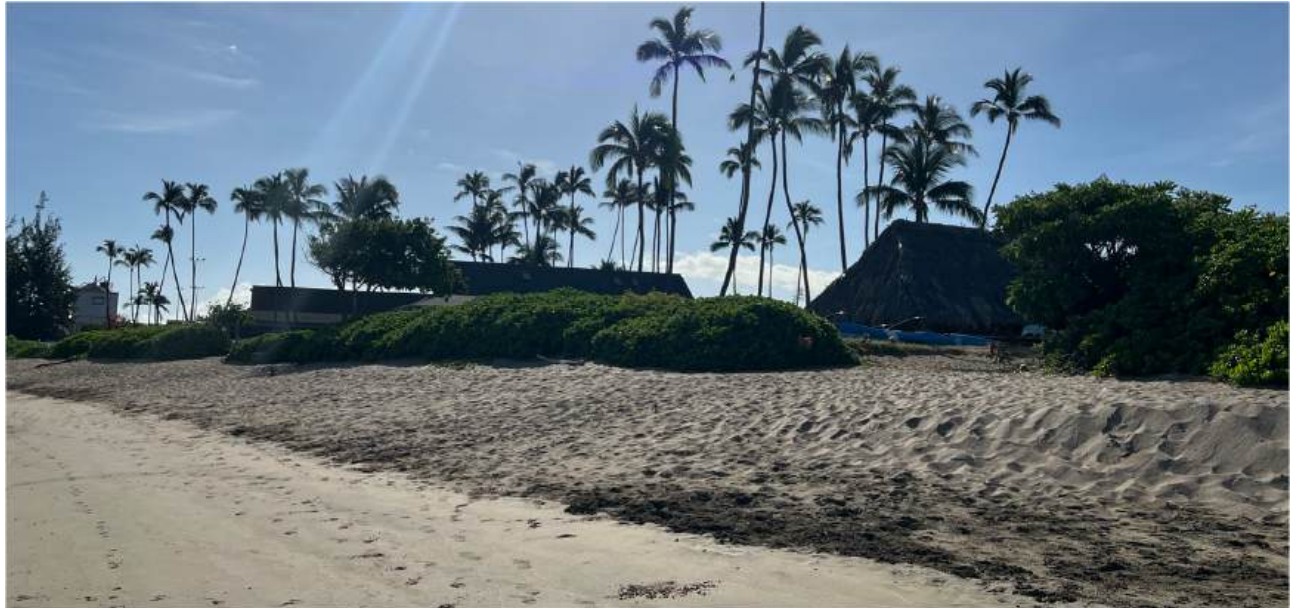
Along the shoreline of the site, specifically along the coastal dunes, naupaka is used as an informal hedge between the canoe hales and the beach. Naupaka, one of the most widely used of all native plants at beach parks, requires low maintenance and minimal irrigation. When allowed to grow, naupaka can contribute to prevent erosion and minimize shoreline hardening. Plants can be used as an informal hedge, or as a windbreak against prevailing sea breeze. Figure 4.9 is a photo of the existing naupaka along the coastal dunes that buffer the site from the shoreline. Gaps in hedge reflect access points from the park to the beach.

Figure 4.9 Naupaka hedge at coastal dune (Brown and Caldwell)

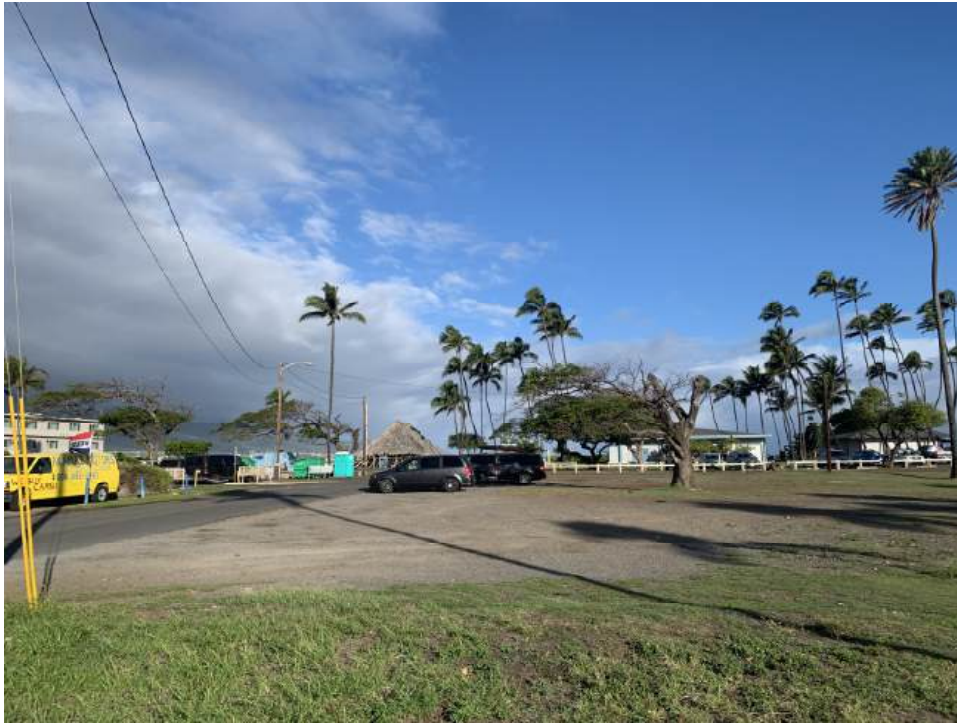
Photo 1: Start of Heterodox View Ave off of W Kaahumanu Ave. Unpaved Field/Overflow Parking shown on the right, Heterodox View Ave shown on the left.

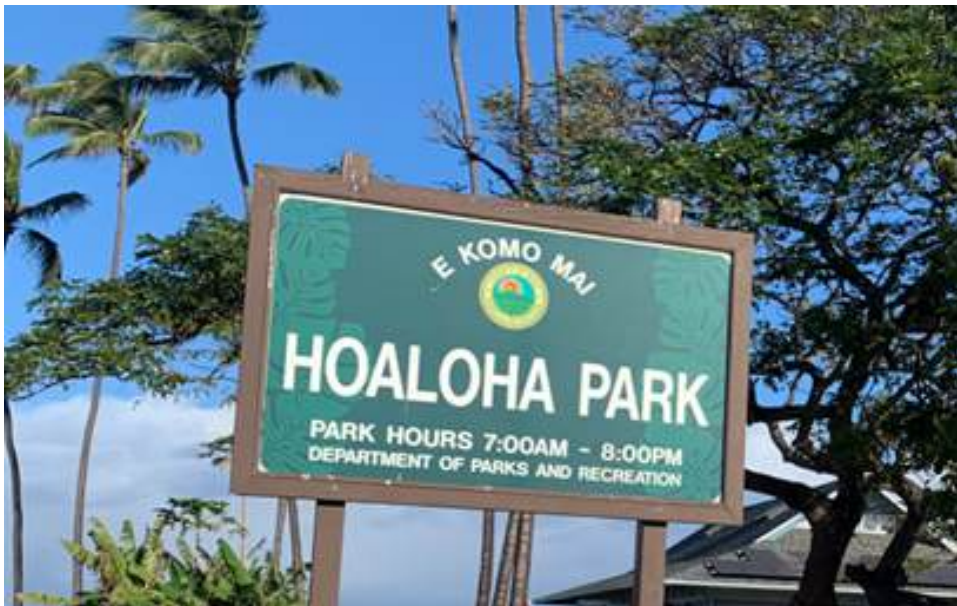
Photo 2: Hoaloha Park Sign. Sign on Heterodox View Ave past the unpaved field.

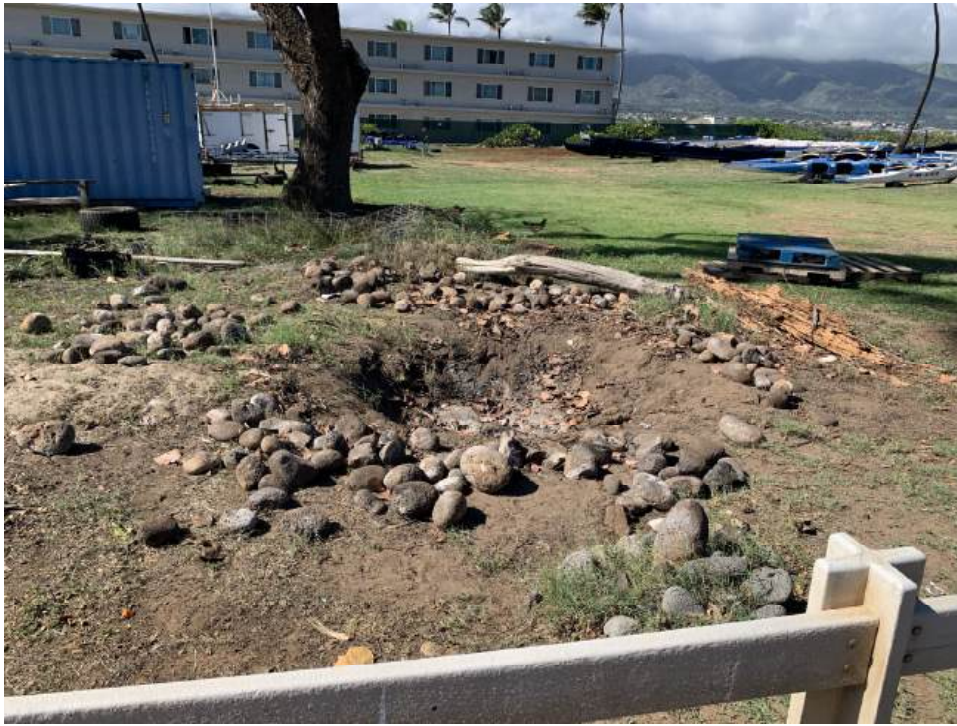
Photo 3: Imu. Located adjacent to 2nd Street and Heterodox View Ave, near the Traditional Hale.

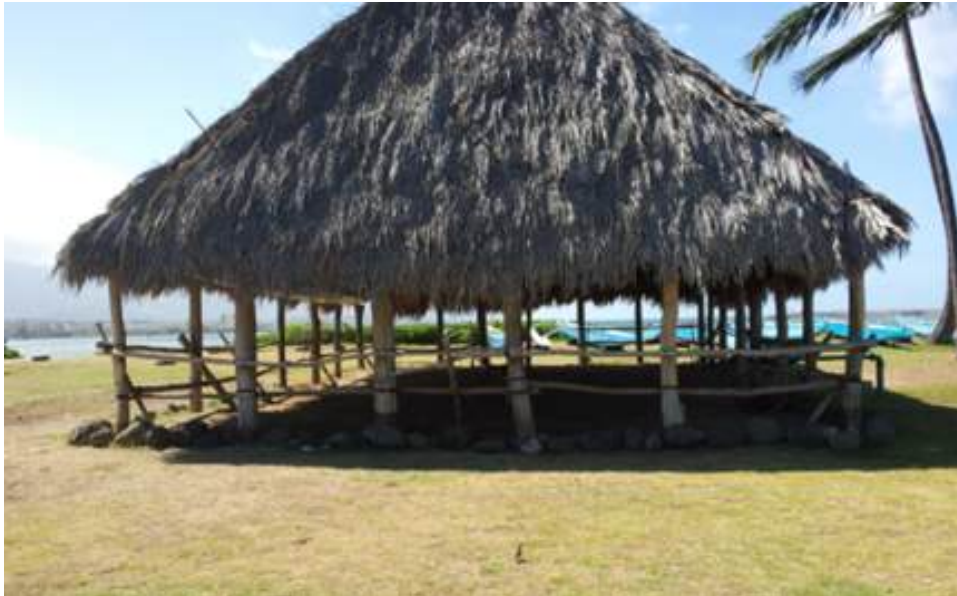
Photo 4: Traditional Hale. Canoe and beach access from the Traditional Hale. Adjacent to the Hawaiian Canoe Club Hale.

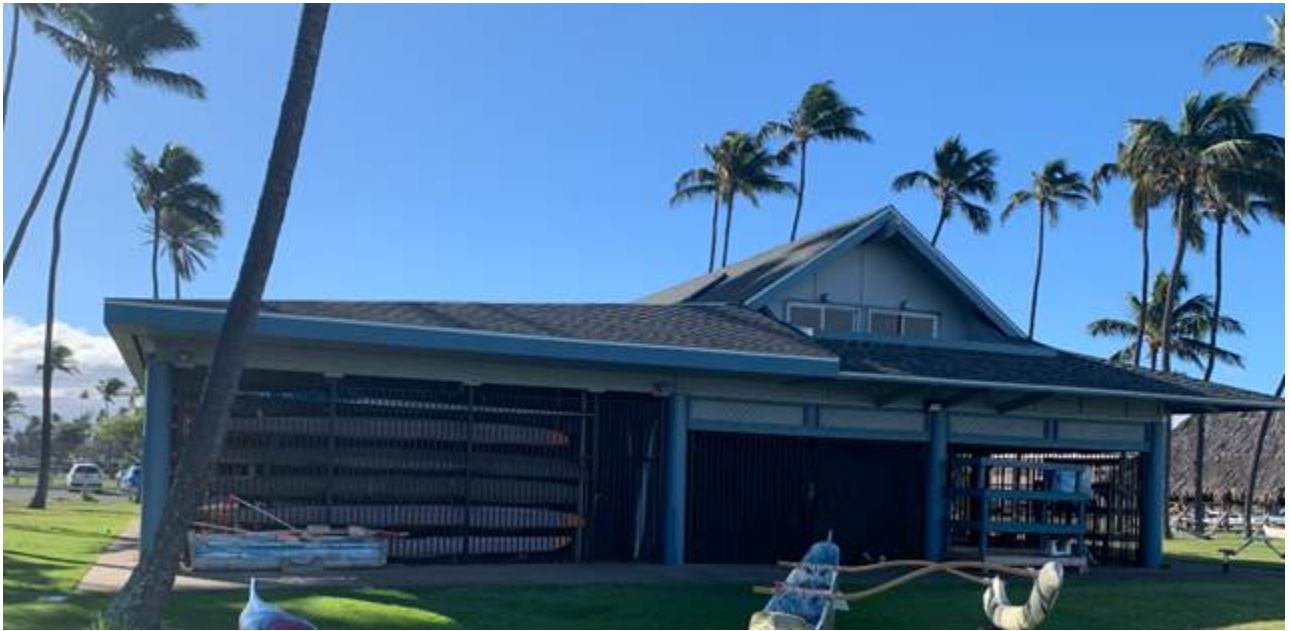
Photo 5: Hawaiian Canoe Club Hale. Facing W Kaahumanu Ave. Traditional Hale shown on the right, and Hoaloa Park parking shown on the left.

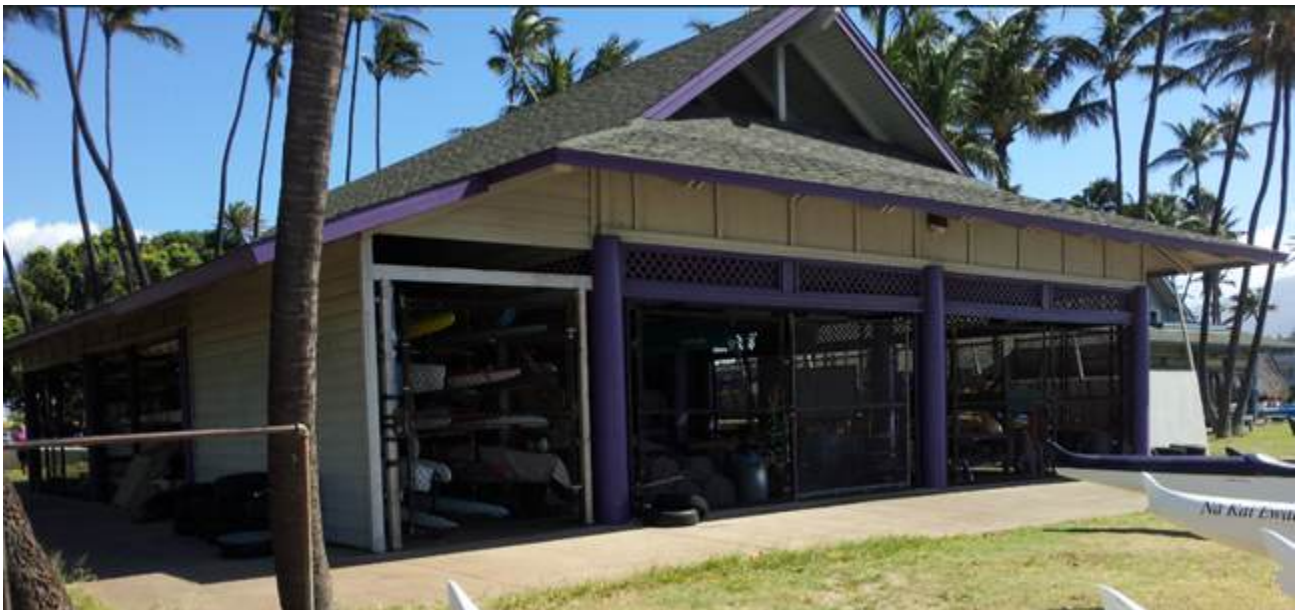
Photo 6: Na Kai Evalu Canoe Hale. Facing Kaahumanu Ave. Hawaiian Canoe Club Hale and Traditional Hale on the right.

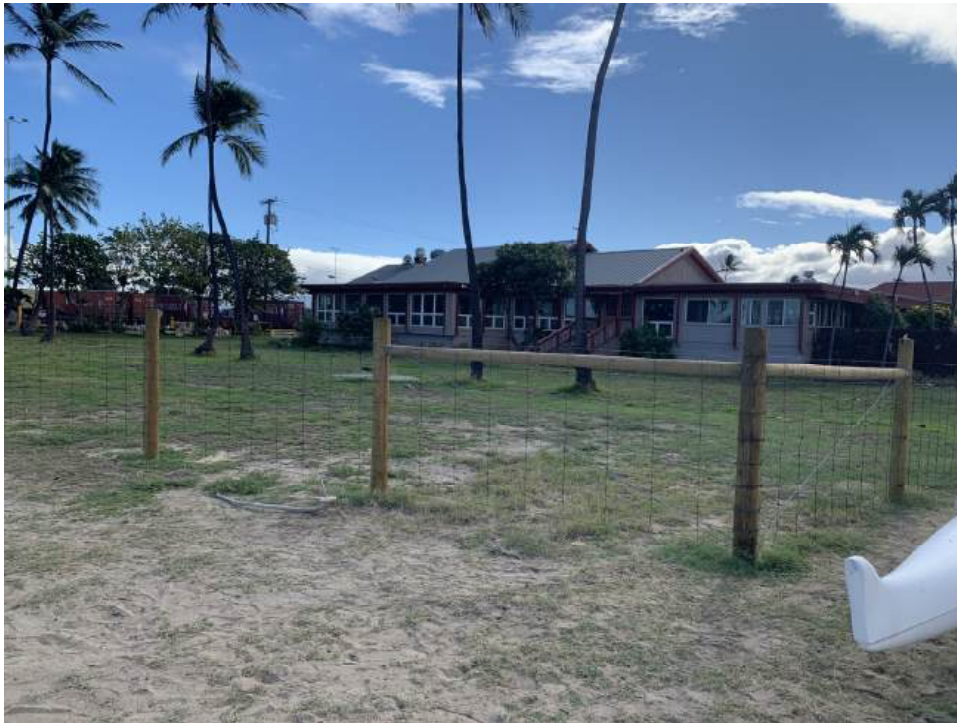
Photo 7: Café O'Lei. Facing W Kaahumanu Ave. Adjacent to the Na Kai Evalu Canoe Hale.

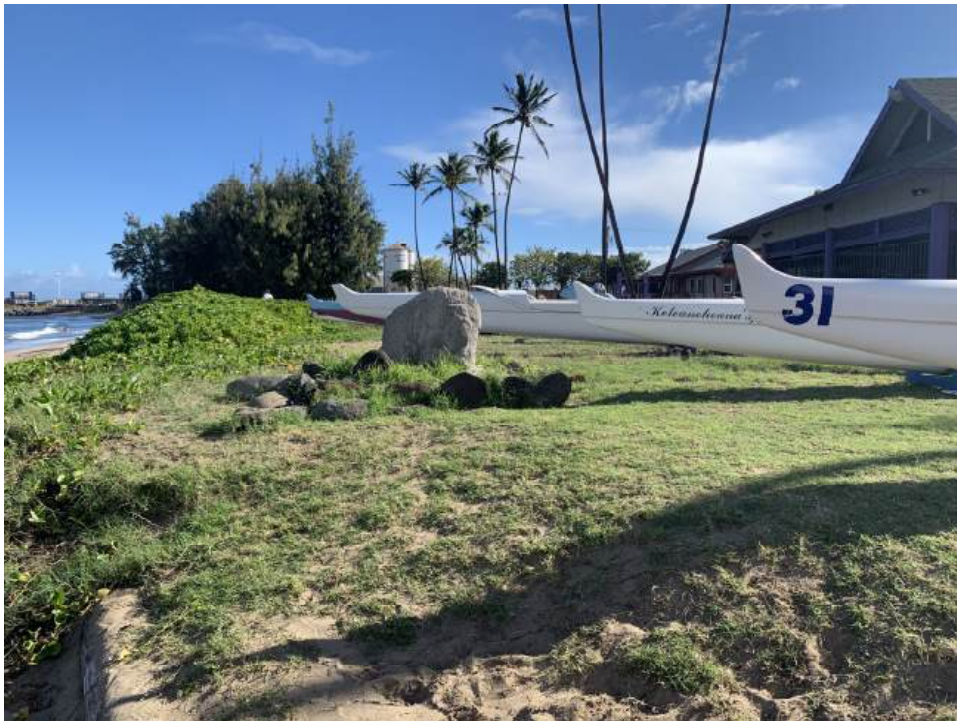
Photo 8: Pohaku. Located between the Hawaiian Canoe Club Hale and the Na Kai Evalu Canoe Hale. Na Kai Evalu Canoe Hale and Café O'Lei on the right. Kahului Harbor, ocean and Pier 2 on the left.

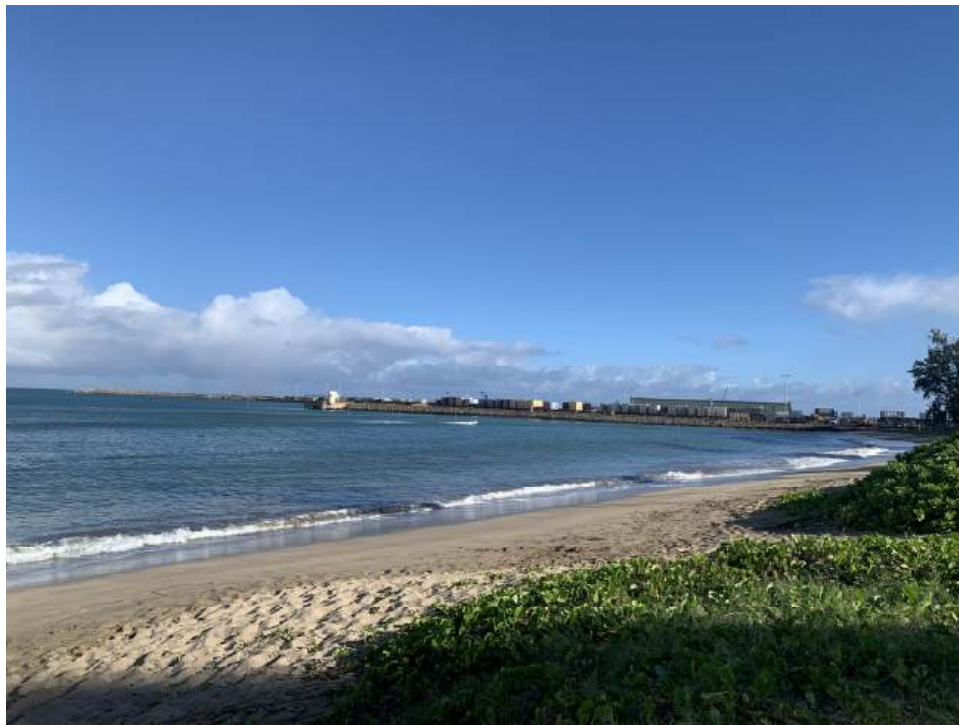
Photo 9: Beach access and Kahului Harbor. Pier 2 in the background.

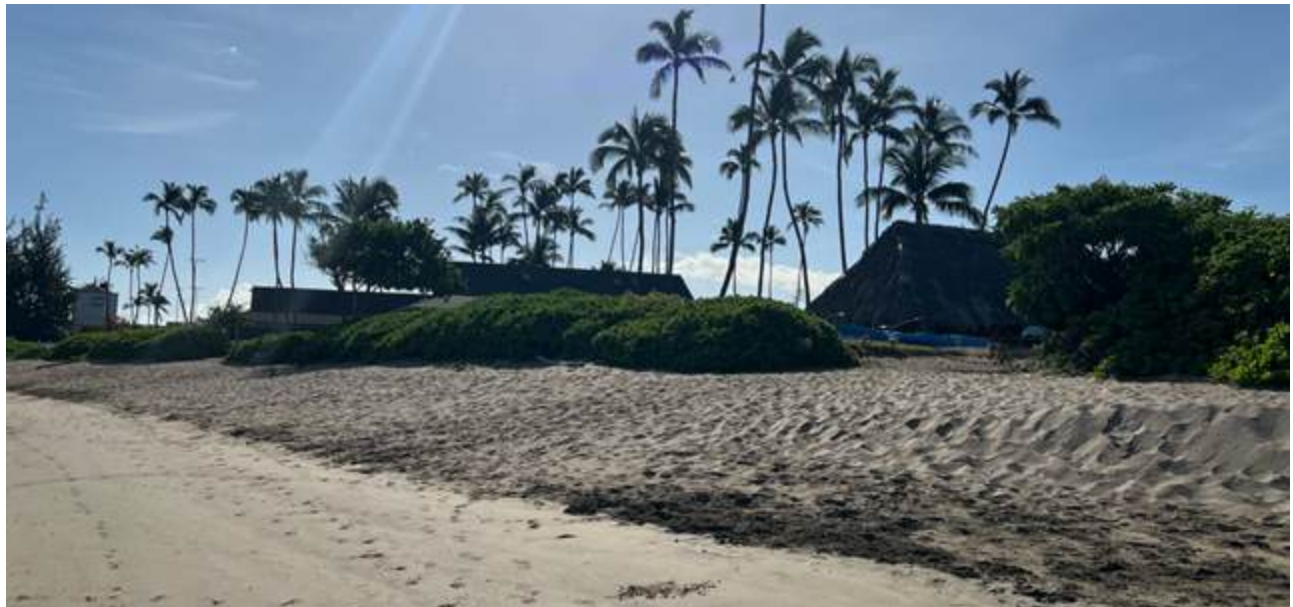
Photo 10: Naupaka hedge at coastal dune between the canoe haies and the beach. Traditional Hale shown on the right, Hawaii Canoe Club in the center, and Na Kai Evalu on the left.

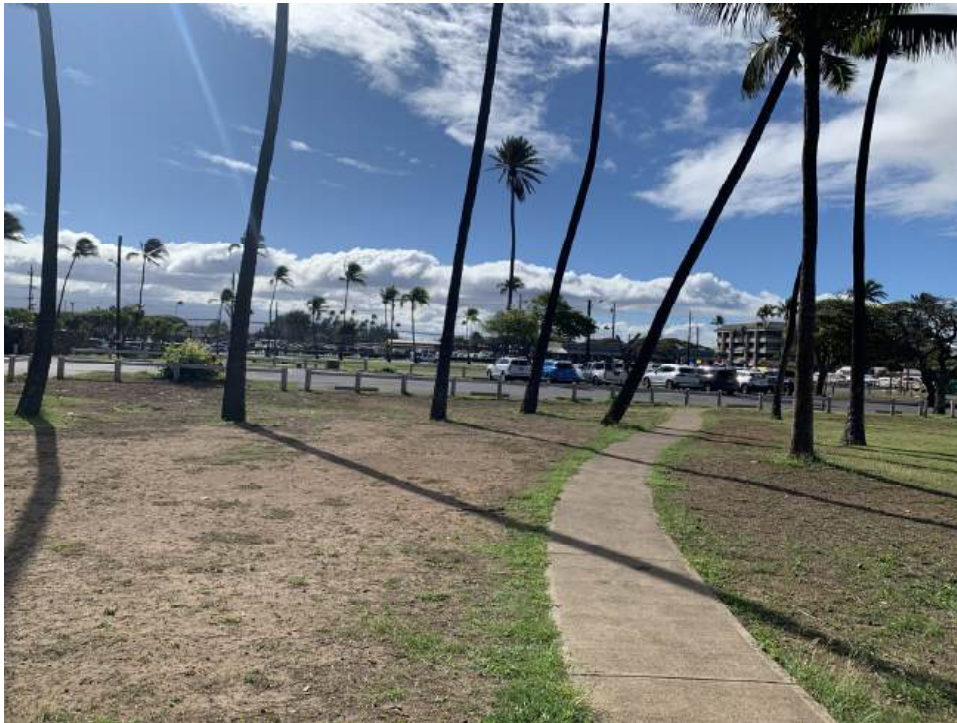
Photo 11: Park Access Walkway. Facing towards the Hoaloha Park Parking and W Kaahumanu Ave. Walkway located between Na Kai Evalu Canoe Hale and Café O’Lei.

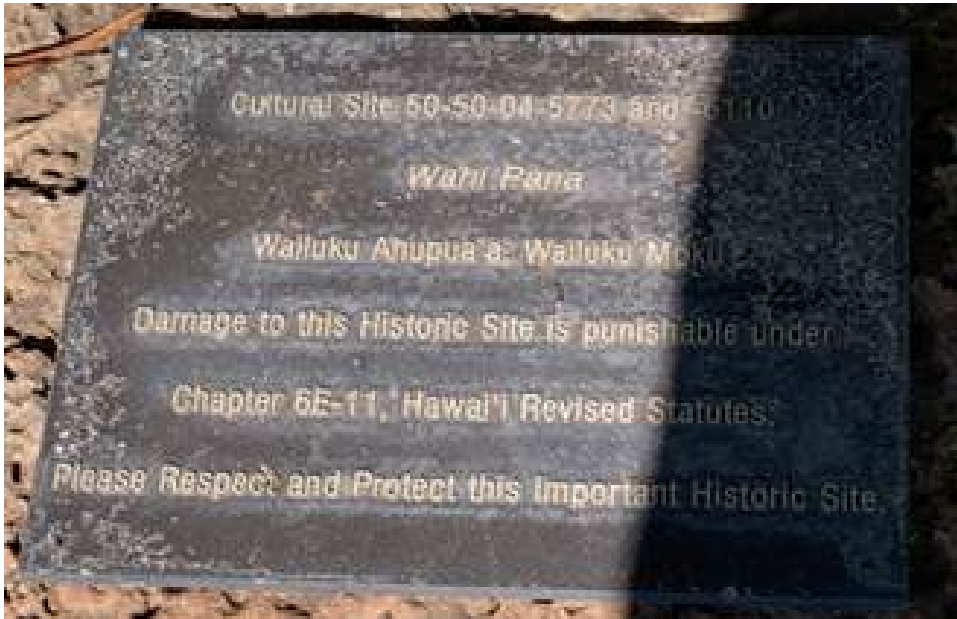
Photo 12: Cultural Site 50-50-04-5773 and -6110. Located adjacent to the Hawaiian Canoe Club Hale.

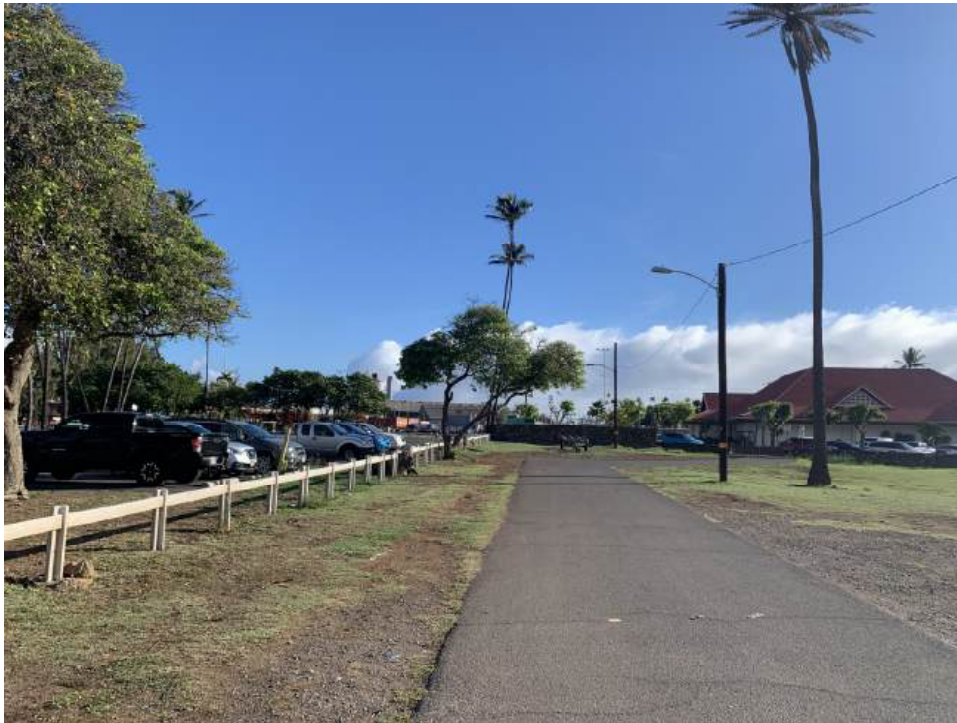
Photo 13: 2nd Street off of Heterodox View Ave. Overhead electrical and First Hawaiian Bank shown on the right, Hoaloha Park parking on the left.
