Project Title: Hoaloha Park Adaptation Plan

Technical Memorandum No. 1

Subject: Site Existing Conditions

Date: August 30, 2024

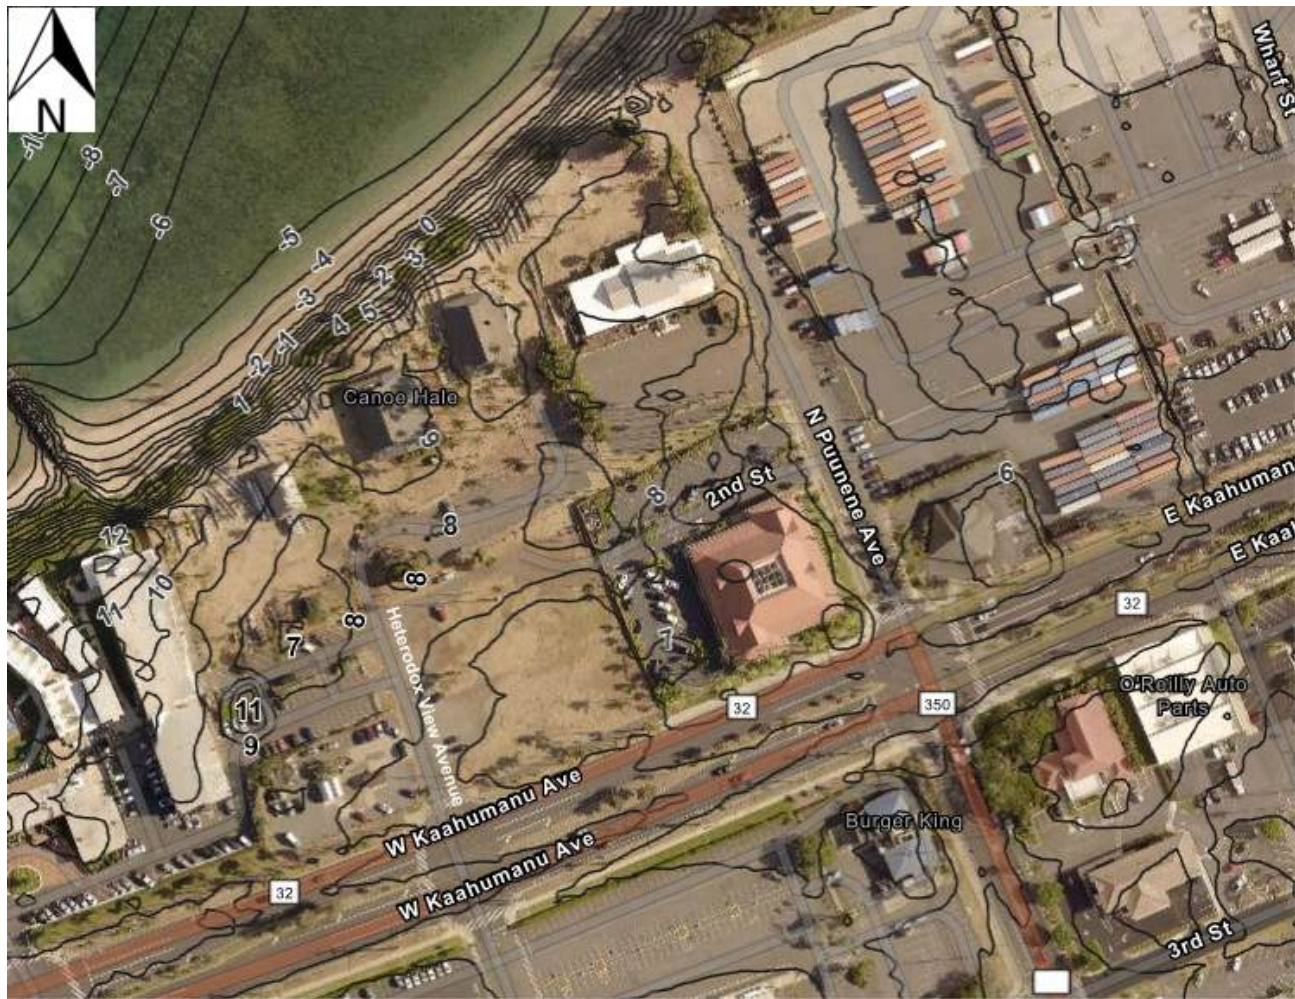
Figure 4.3 Topographic Map (County of Maui)

The site elevation ranges from 3 feet to 10 feet above mean sea level, where the primary elevation gain occurs along the shoreline boundary at the existing coastal sand dune system. The site elevation peaks on the shoreline boundary at 9 to 10 feet, and then slopes in the southerly direction towards Ka’ahumanu Avenue. Within the site, there are various low spots where ponding may occur such as north of Ka’ahumanu Avenue and north of the Maui Seaside Hotel parking lot. Except for the sand dunes at the shoreline, the site slopes are mild, ranging from 0 to 5 percent. Figure 4.3 represents the site topography.

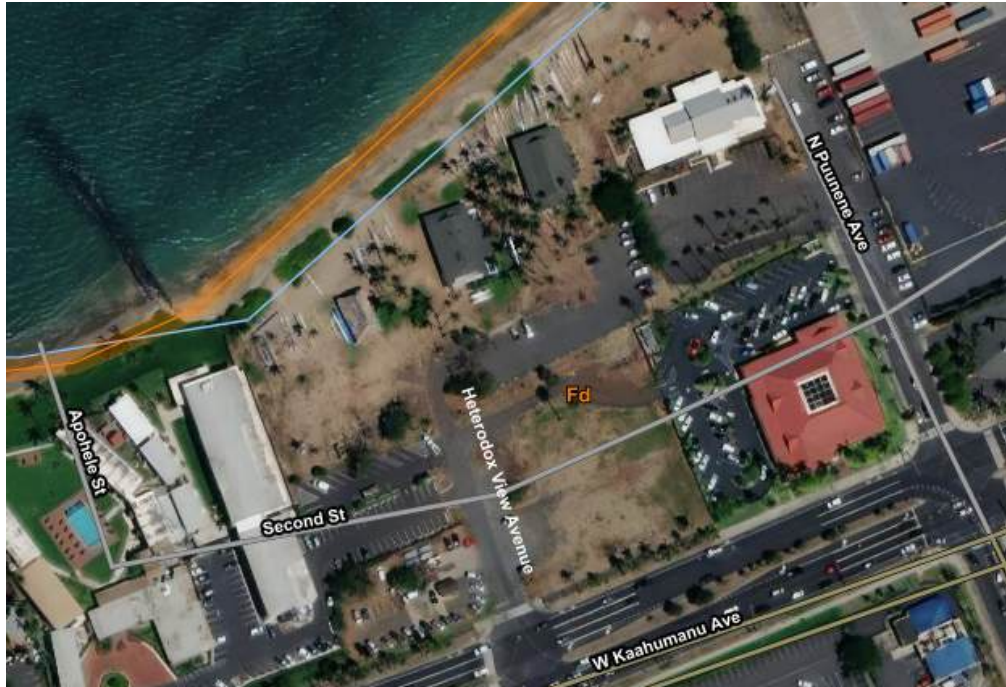
Figure 4.8 Soil Survey Map (USDA)

Soils on the site are classified as Fd or “fill land” in the United States Department of Agriculture, Natural Resources Conservation District’s National Cooperative Soil Survey (Figure 4.8). The surface soil is identified as cobbly sandy loam and exists to a depth of 30 inches. The soil is sand from 30-60 inches below ground surface, and bedrock at approximately 60-64 inches. Slopes are generally 0 to 3 percent and considered flat. The soils are considered hydrologic soil group B, known to have moderate to high infiltration rate when thoroughly wet. These soils are known to be moderately fine to moderately coarse texture. The shrink-swell potential is low, and the soil is occasionally flooded, but not ponded.

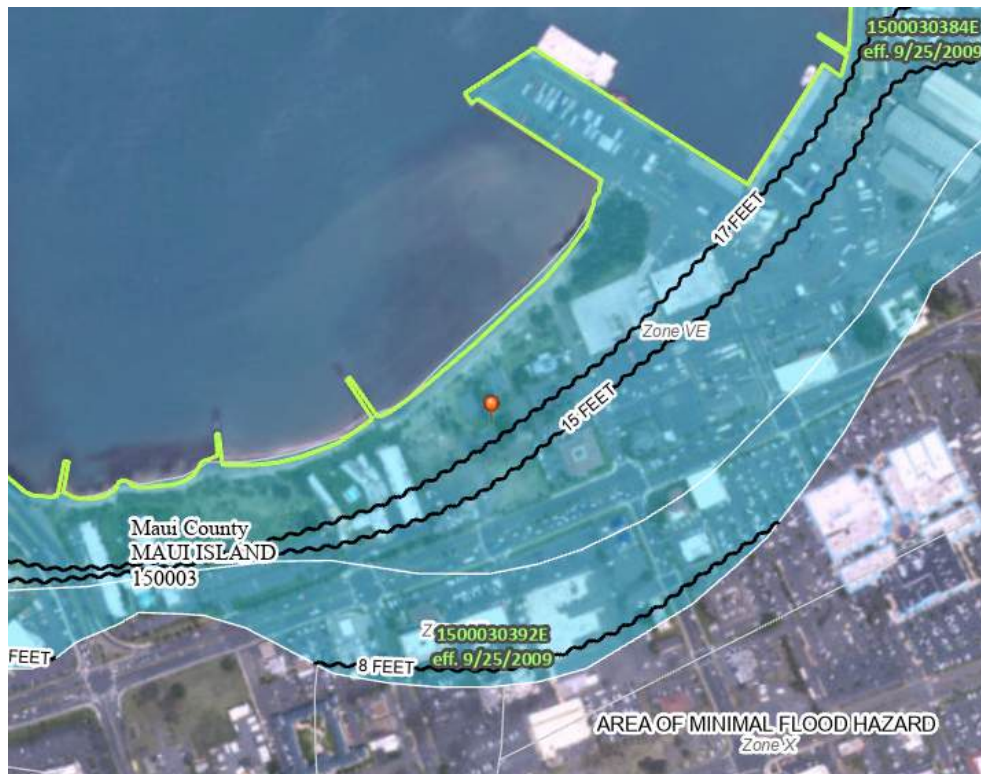
Figure 4.11 FEMA FIRM Map (FEMA)

The site is mapped as a Special Flood Hazard Area (SFHA) by the Federal Emergency Management Agency (FEMA). Flood Insurance Rate Maps (FIRMs) identify the SFHA, which are defined as areas that will be inundated by a flood event having a 1-percent chance of being equaled or exceeded in any given year. The 1-percent annual chance flood is also referred to as the base flood or 100-year flood. Hoaloha Park is in zone VE, which is considered a high-risk coastal zone, where wave action greater than 3 feet in height and fast-moving water can cause extensive damage during a base flood event. Figure 4.11 shows that the site is within the VE coastal hazard zone.

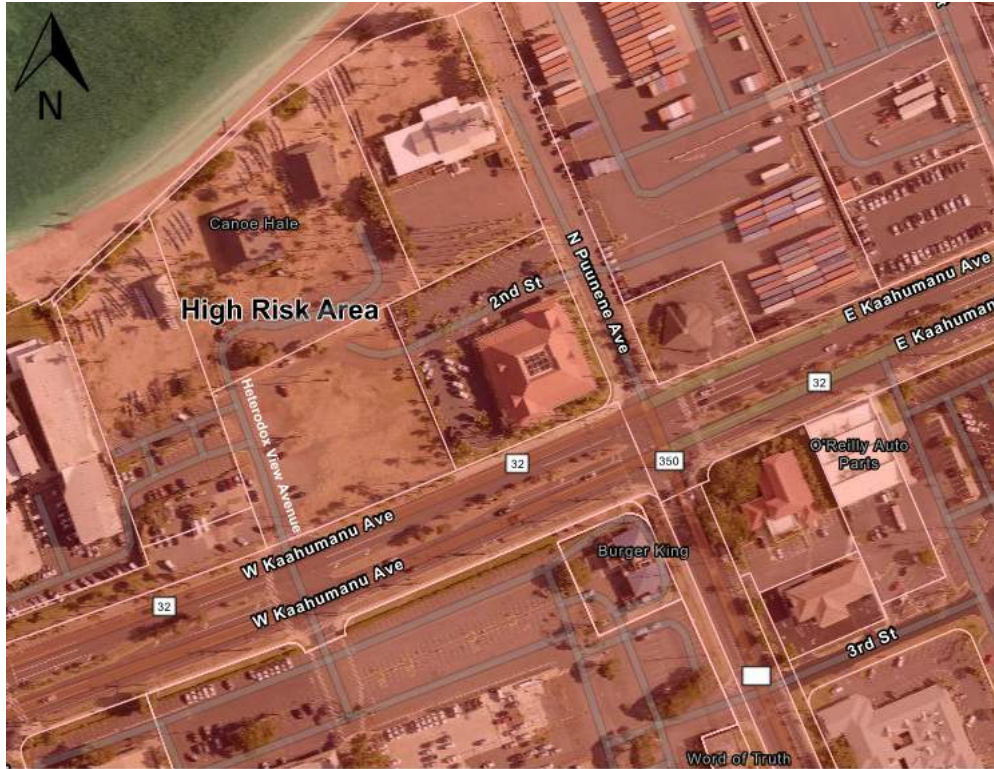
Figure 5.1 High Fire Risk (County of Maui)

Wildfire data for this risk was made available through the State of Hawai'i, Division of Forestry and Wildlife, which identified at-risk wildland-urban interface communities and provided a risk rating. Wildfire is included as a hazard within this study due to the increasing prominence of wildfire events. These types of hazards are relevant for the operations and maintenance of the park's infrastructure and for potential adaptation considerations. Fire on or adjacent to the site can lead to increased runoff and erosion that may impact flooding around the site. This can also affect water quality at the shoreline and would impact park users by impairing water use due to poor water quality.

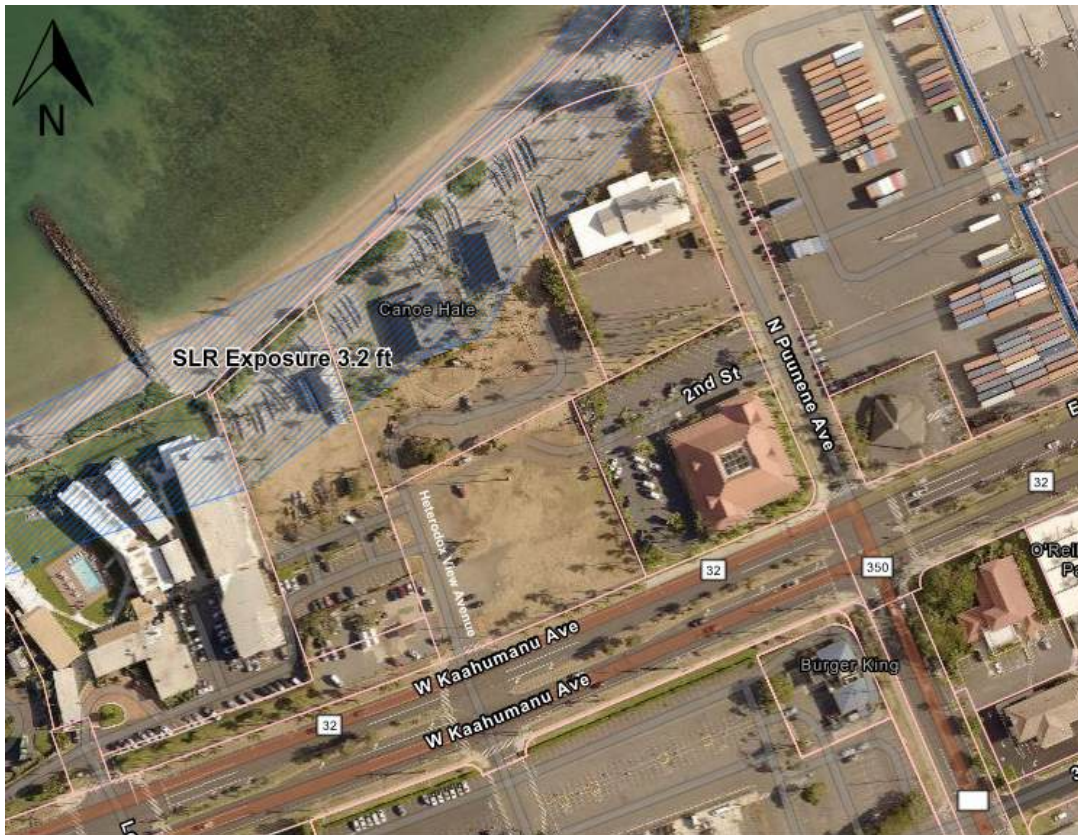
Figure 5.2 SLR Exposure 3.2 Ft (County of Maui)

There are several climate related hazards that may lead to flooding at or adjacent to the site. Two sea-level-rise (SLR) related hazards considered are passive flooding and high wave flooding. Figure 5.2 shows that SLR exposure of 3.2 feet, anticipated at end of the century, will significantly inundate the site. Inundation is likely to extend beyond the existing canoe hale structures and storage, but not as far as the paved parking lot.

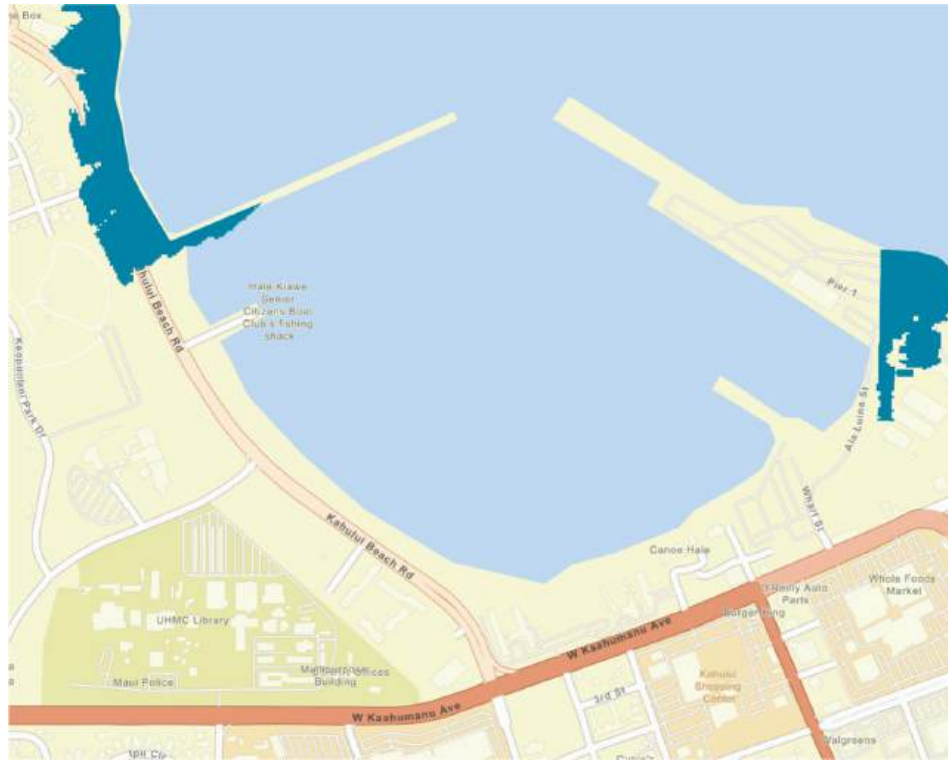
Figure 5.4 SLR Annual High Wave Flooding 3.2 Ft. Scenario (State of Hawai'i)

High wave flooding, also known as annual high wave flooding, is the maximum annual significant wave, which can be measured and modeled using peak wave period and direction, and significant wave height. At a SLR exposure of 3.2 feet, figure 5.4 shows that while the park is not expected to be impacted by high wave flooding, Kahului Beach Road is likely to be impacted and may limit accessibility to the park.

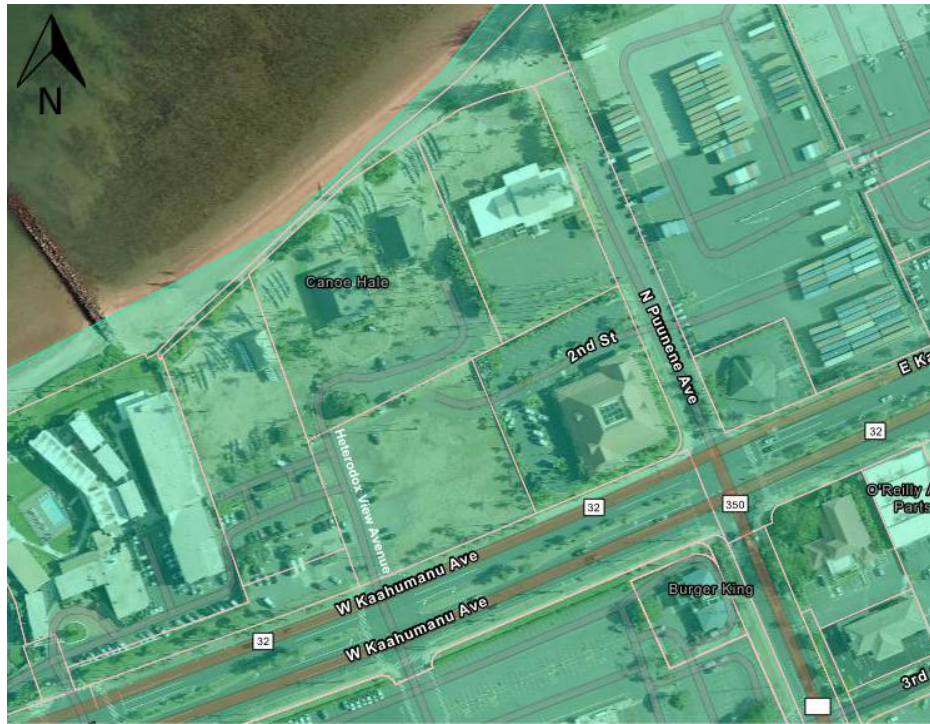
Figure 5.5 Tsunami Zone (County of Maui)

As shown in figure 5.5, the site is also located in the tsunami zone, with the extreme tsunami zone extending further inland from the site. Although tsunamis are generally considered a seismic-related hazard, warming ocean temperatures leading to thermal expansion and increasing sea levels can increase tsunami damage potential. In this case, with SLR, tsunamis could reach farther inland with potentially greater destructive force.
